**SUBJECT:** An elevator mechanic helper died when he was crushed in an escalator while performing maintenance.

**SUMMARY**  
**California FACE Report #01CA009**

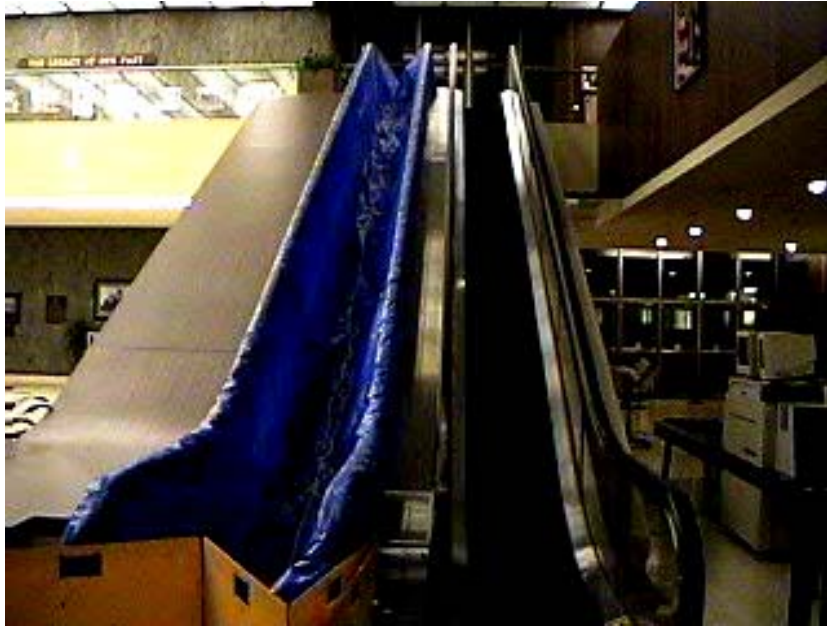
01CA009  
Exhibit #1

The site of the incident was a county court multi-story facility. The escalator involved in this incident was the #2 escalator located in the main lobby between the first and second floors (**see exhibit #1**). The #2 escalator was used mainly to transport people down to the first floor from the second floor. The floor plate at the second floor escalator landing covered a small compartment referred to as the machine room, which contained the electrical and mechanical components to operate the escalator (**exhibit #6**).

View of the escalators running between the lobby and second floor of the courthouse. The escalator on the left was involved in the incident.

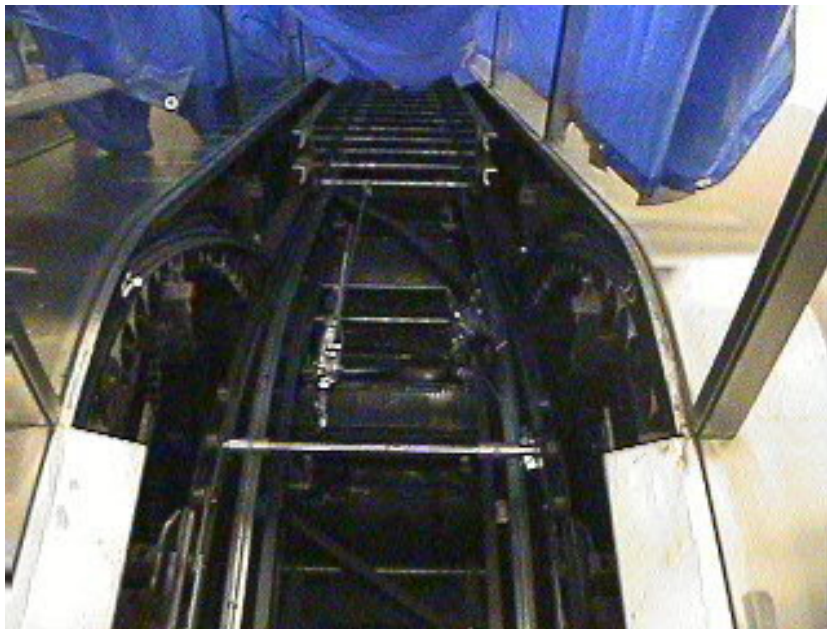
01CA009  
Exhibit #2

View of the #2 escalator landing with the stairs removed exposing the escalator truss.

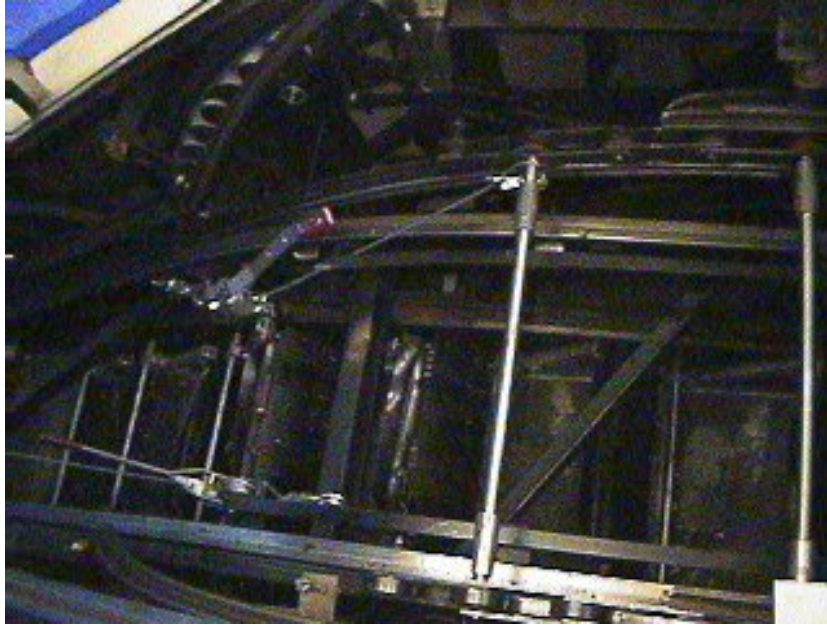
Exhibit #3

According to the co-worker, he double-checked to assure that the main line disconnect switch was in the off position. He opened the floor plate and re-checked the switch. After their morning break, the victim entered the escalator truss and continued his work (**exhibit #3**). The co-worker stepped into the machine room to help the victim with his work. In order to make more room to maneuver within the machine room and to expose the sprocket and drive train, the co-worker had to remove the electrical control box and place it on the floor. The electrical control box weighed approximately 70 pounds. As the co-worker picked up the control box, the flex-cable connected to the electrical control box inadvertently got caught on the main line disconnect switch and turned it on (**exhibit #4**). The co-worker continued picking up the control box then dropped it outside the machine room on the floor to his left. The relay inside closed

from the jarring of the drop and the escalator came on and starting moving down. The co-worker stated that when he saw the steps moving downward he immediately tried to stop them by jamming a steel bar into the truss mechanism but his attempts failed.

View of the escalator truss with the stairs removed. This is where the victim was working when the escalator suddenly came on.

#### **Recommendation #3: Ensure employees block mechanisms from moving prior to performing repairs or maintenance.**

Discussion: This escalator was equipped with mechanical blocking devices. These were not used during this incident. Machines that are capable of crushing or striking workers should be blocked with wood or by blocking devices mounted on the machine prior to the start of service or maintenance.

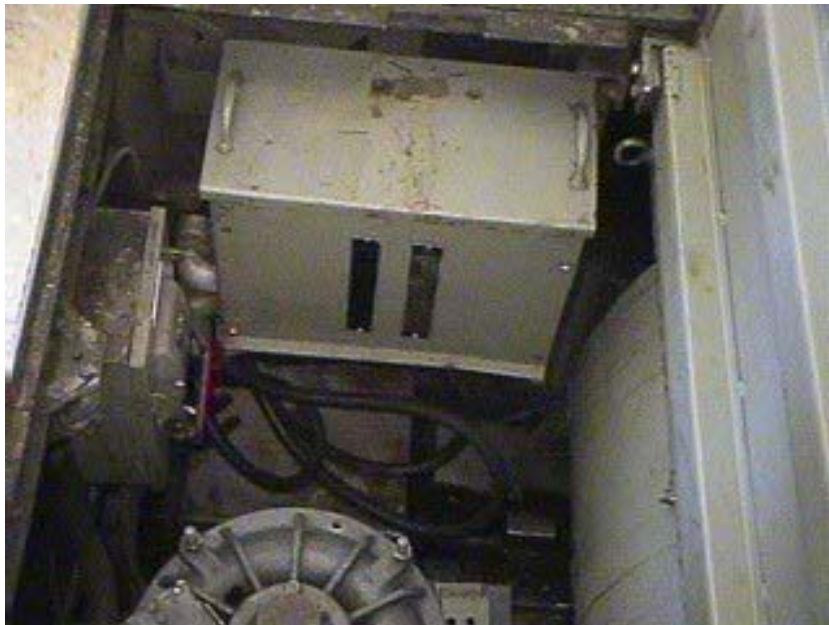
Exhibit #4

Discussion: The company adopted and implemented the elevator industry's policy on lock-out/tag-out. In this incident there were no lockout/tagout procedures used although it was required. The victim and his co-worker depended solely on the main line disconnect switch to remain in the off or open position. The flex-cable attached to the electrical control box turned the main line disconnect switch on when the electrical box was picked up. A lock on that switch would have prevented this from occurring. The main control panel supplying power to the escalators within the building should have been opened and locked and tagged as well. This was not done. The safety practices and procedures noted in the elevator industry's safety handbook are specific for this type of work. Had these general rules been followed, this incident might have been prevented.

Discussion: The victim's coworker moved and dropped the escalator control box while the victim was in the escalator. This powered up and switched on the escalator, resulting in the death of the victim. Safe work practices can be assured through programs of training, supervision, rewards, and progressive disciplinary measures.

A view of the machine room showing the electrical control box in the center and the main line disconnect with a bar handle to the left.

#### **Recommendation #1: Ensure employees follow company policy and procedures on lockout/tagout.**

#### **Recommendation #2: Ensure employees do not move electrical escalator equipment when all or part of someone is inside the escalator mechanism.**

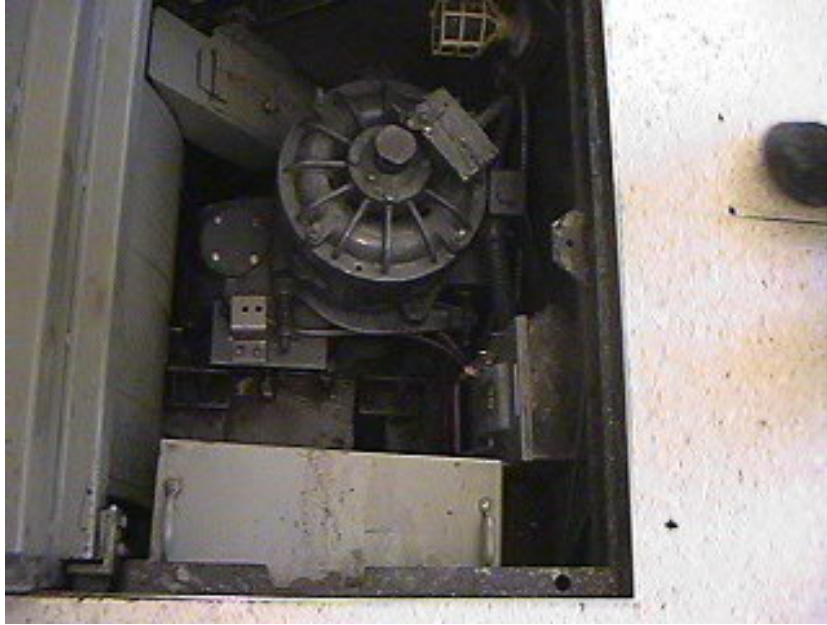
Exhibit #5

A view of the machine room with all its components depicting its size.

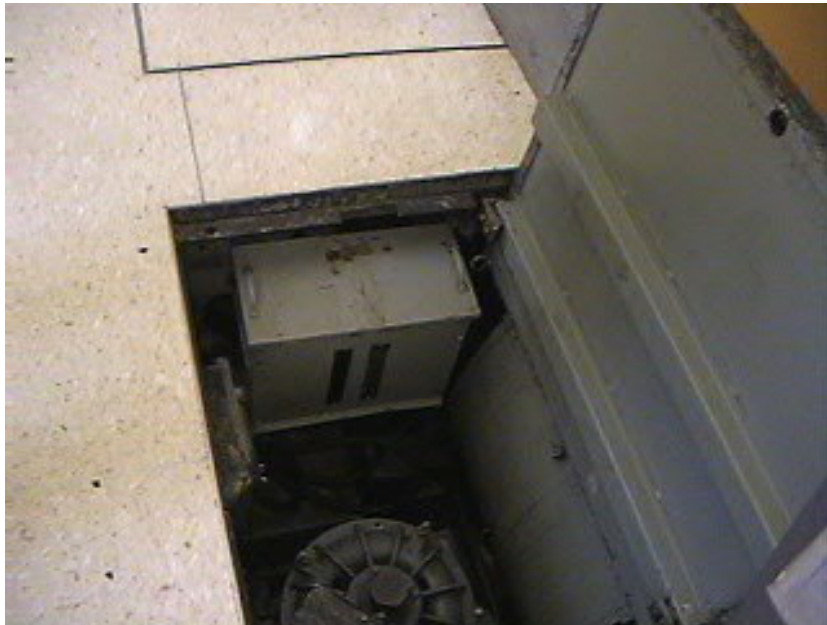
Exhibit #6

View of the machine room with the floor plate opened.
